RE: DEP File No 142-0231, SunnyDayz ANRAD Filing

RE: : Greenfield Road (Rt. 5) Site, Deerfield, MA.
Wetland Resource Area Delineation Report 2

SunnyDayz, Inc.
Greenfield Road (Rt. 5) Site, Deerfield, MA.
Wetland Resource Area Delineation Report 2

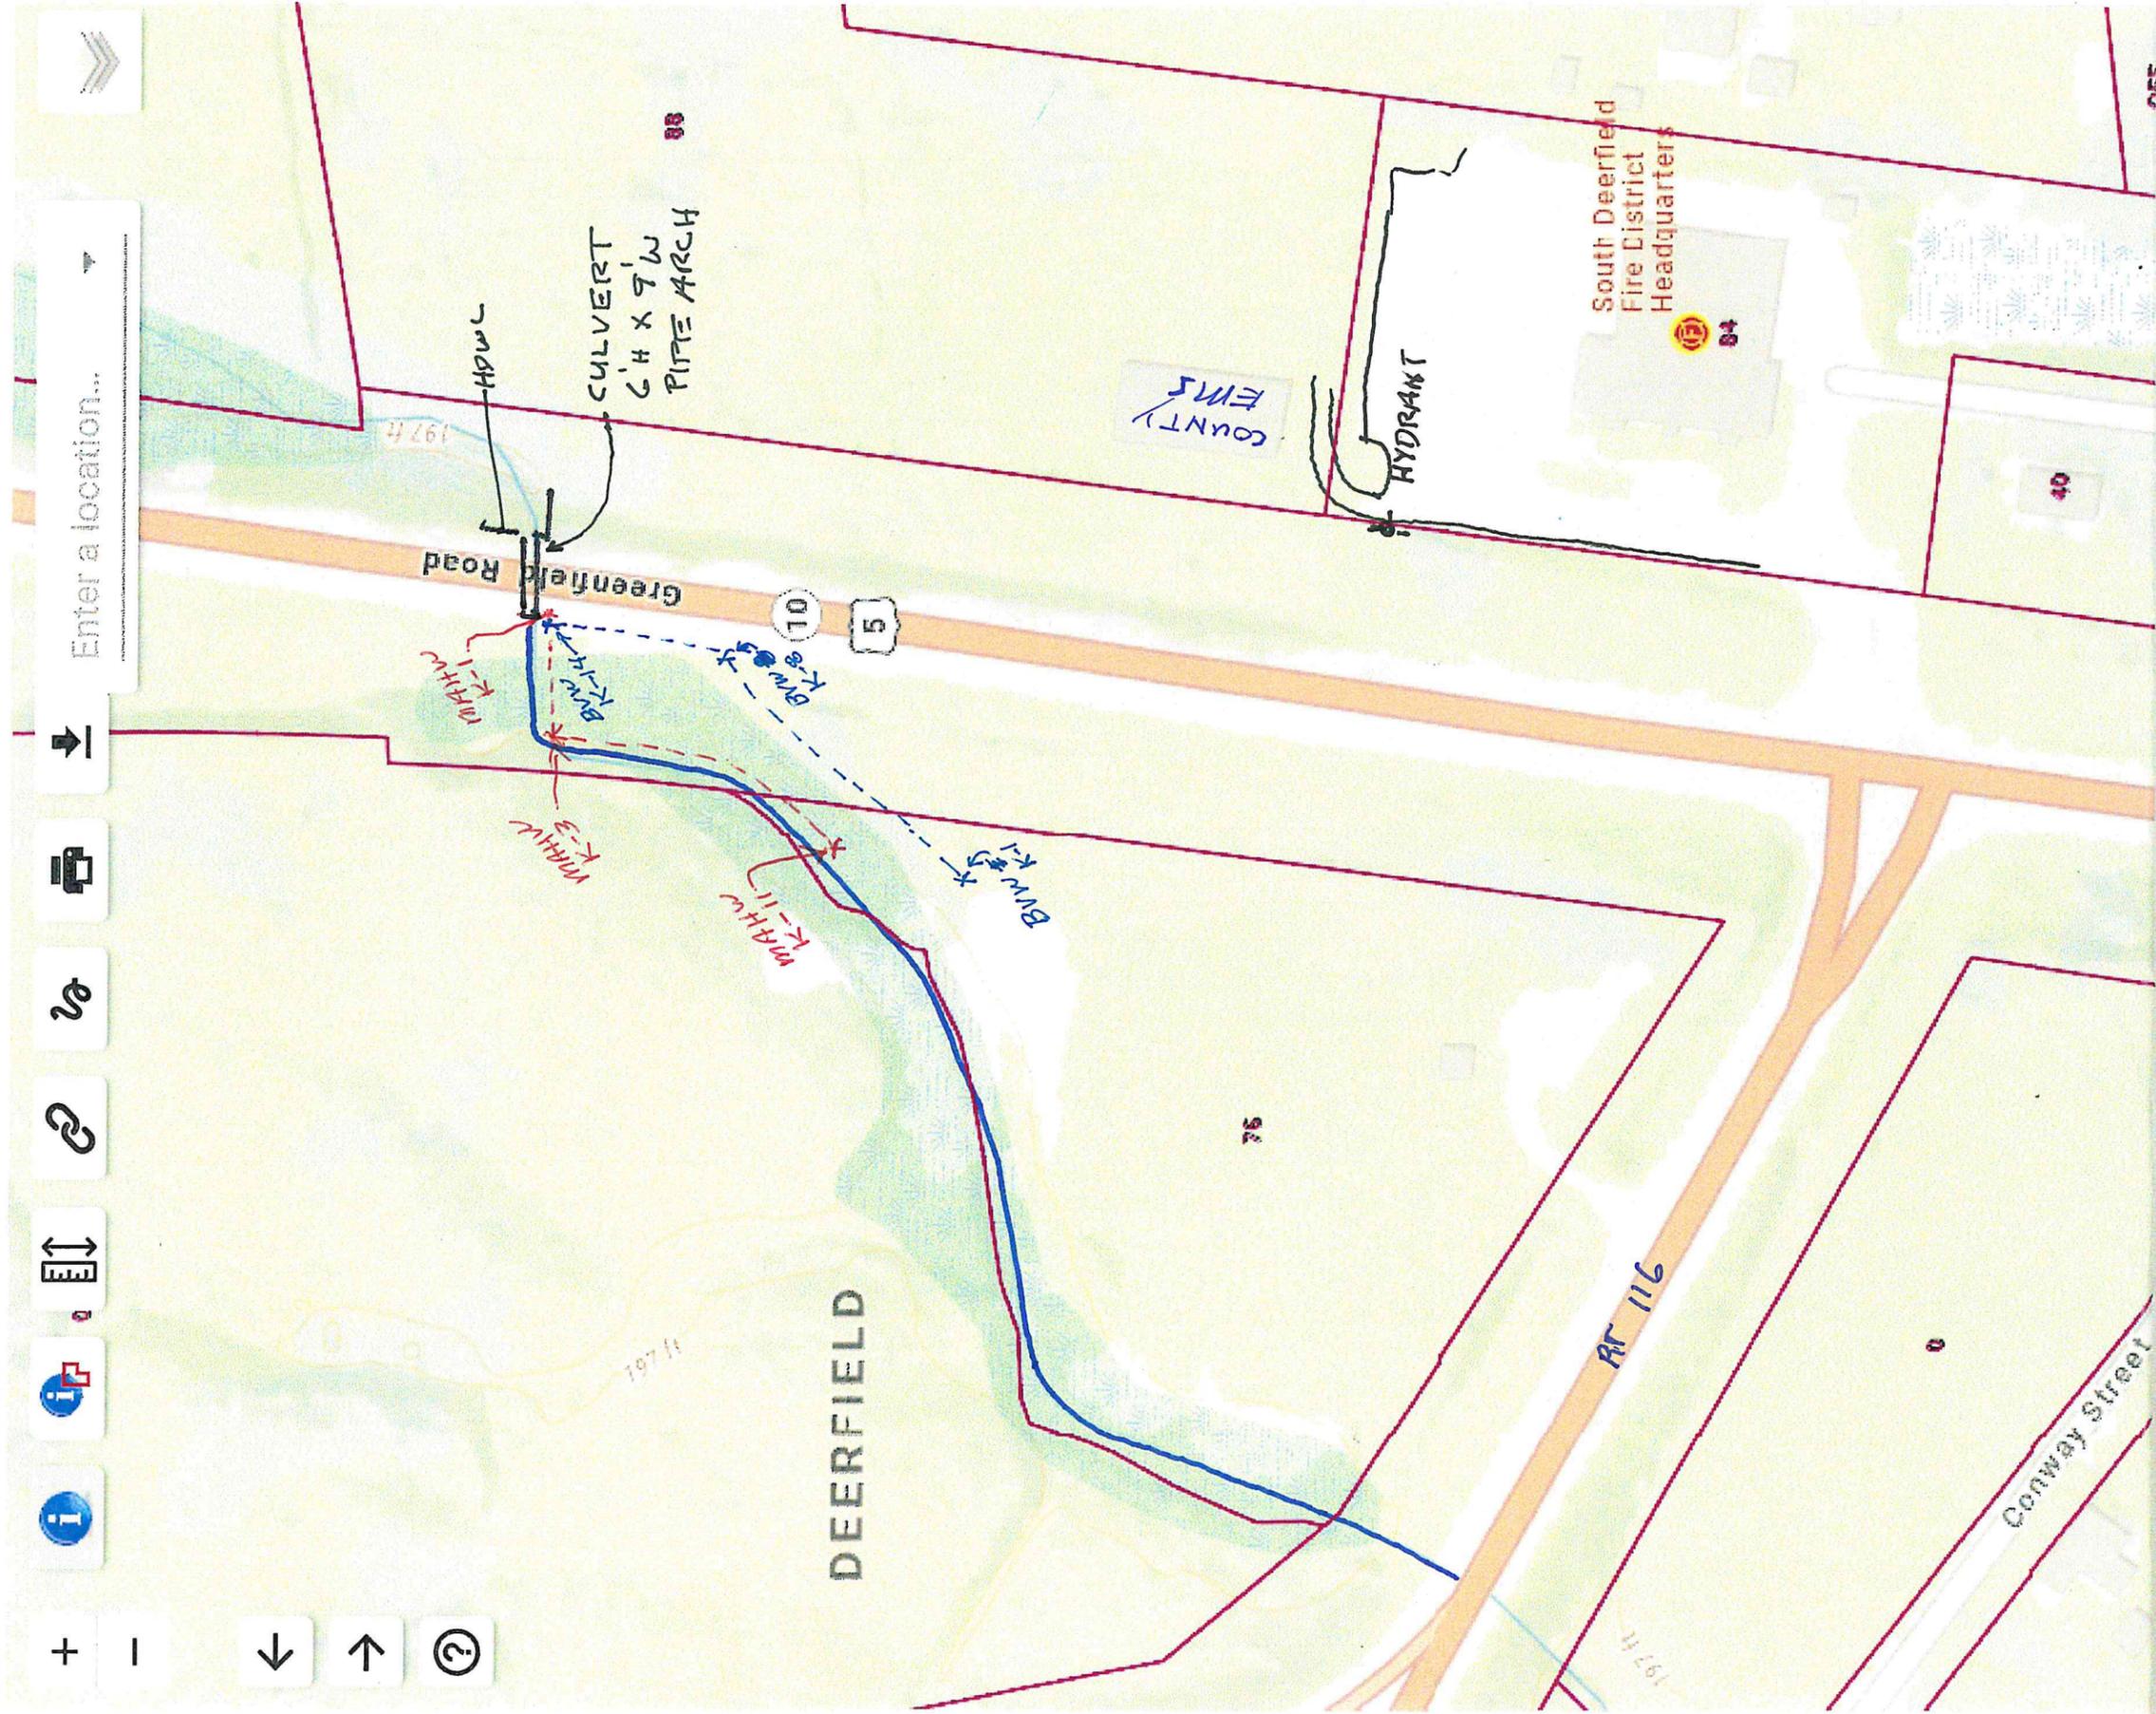
SKETCH OF
WETLAND DELINEATION

Pink survey flagging (ribbon) was used and the flagging begins at MAHW K-1 at the outlet of the culvert off Greenfield Road. The flagging follows to bank southwesterly and ends at flag MAHW K-11, just beyond the road right-of-way.

The BVW boundary was marked with blue survey ribbon labeled BVW K-1 to BVW K-14.

BVW FLAGS = BVW K-1 TO BVW K-14 BLUE RIBBON
 MATHW FLAGS = MATHW K-1 TO MATHW K-11 PINK RIBBON
